From Antique Salvage Timber C.E.: Soils field recon 11/03/03

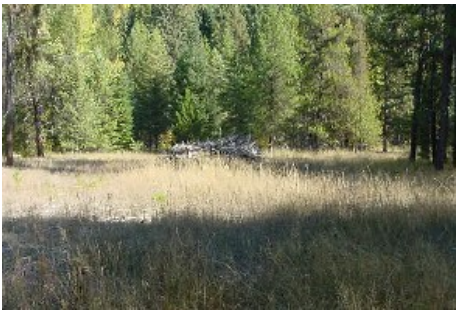
Previous compacted landing with seedlings
Having root constriction.

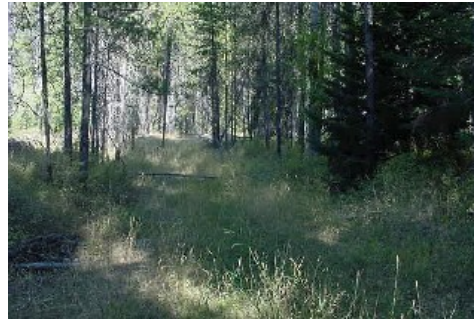
Previous skid road with compaction
